**ACCIDENT**

<b>Aircraft Type and Registration:</b>	Stampe SV4C(G), G-AWEF
<b>No &amp; Type of Engines:</b>	1 De Havilland Gipsy Major 10 Mk.2 piston engine
<b>Year of Manufacture:</b>	1947 (Serial no: 549)
<b>Date &amp; Time (UTC):</b>	9 May 2021 at 1521 hrs
<b>Location:</b>	Near Headcorn Aerodrome, Ashford, Kent
<b>Type of Flight:</b>	Private
<b>Persons on Board:</b>	Crew - 1                      Passengers - None
<b>Injuries:</b>	Crew - 1 (Fatal)           Passengers - N/A
<b>Nature of Damage:</b>	Aircraft destroyed
<b>Commander's Licence:</b>	Private Pilot's Licence
<b>Commander's Age:</b>	57 years
<b>Commander's Flying Experience:</b>	753 hours (of which 517 were on type) Last 90 days - 8 hours Last 28 days - 5 hours
<b>Information Source:</b>	AAIB Field Investigation

**Synopsis**

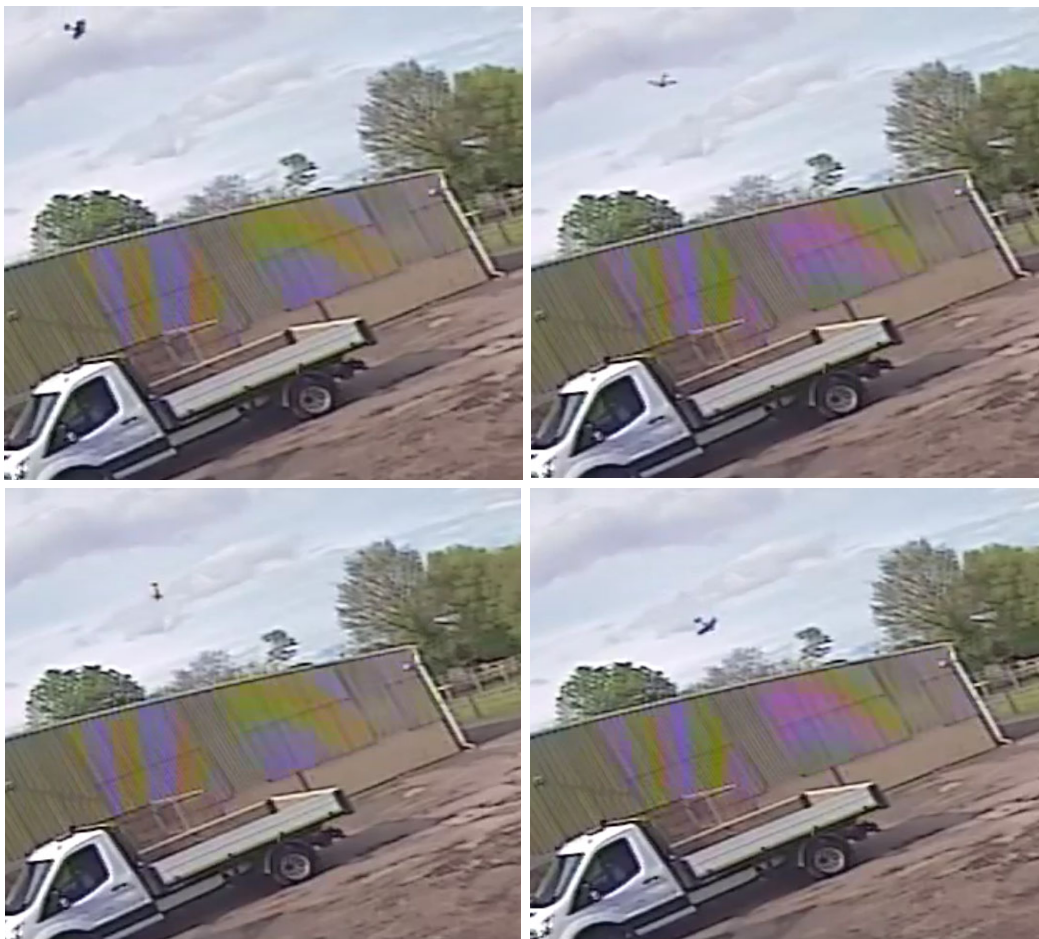
**Figure 3**

Montage from CCTV (used with permission)

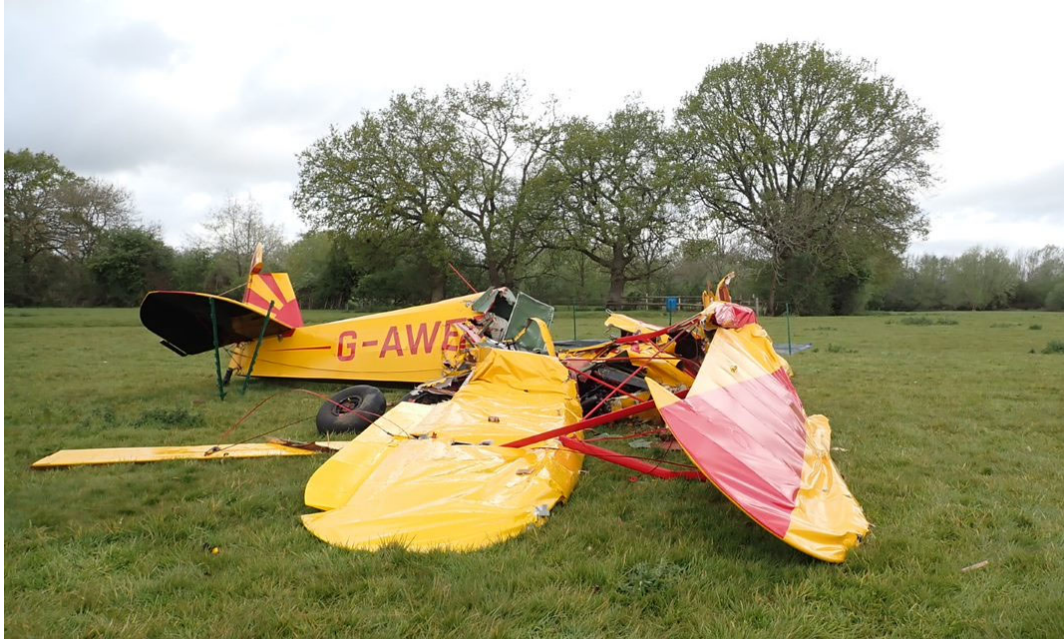
**Figure 5**

The aircraft hit the ground in a large open agricultural field and came to rest upright on a north-easterly heading. Initial examination of the wreckage indicated the aircraft was complete with no vital parts or control surfaces missing. The tail section, from the rear cockpit seat frame aft, was undamaged other than some distortion and splitting of the left tailplane tip structure. Both cockpit areas and the engine bay were extensively fragmented (Figure 5). The upper and lower wing leading edges had been compressed and distorted along the full length of both wings. The upper wing bracing struts and rods had been cut by the first responders and the wing had been moved forward to gain access to the pilot. After the aircraft was removed from the accident site, two distinct parallel marks had been left on the ground by the mainplane leading edges (Figure 6). Comparison of these ground marks with the aircraft's original structural dimensions suggest that the aircraft hit the ground with a 65° nose-down attitude.

Accident site showing tail and mainplane positions

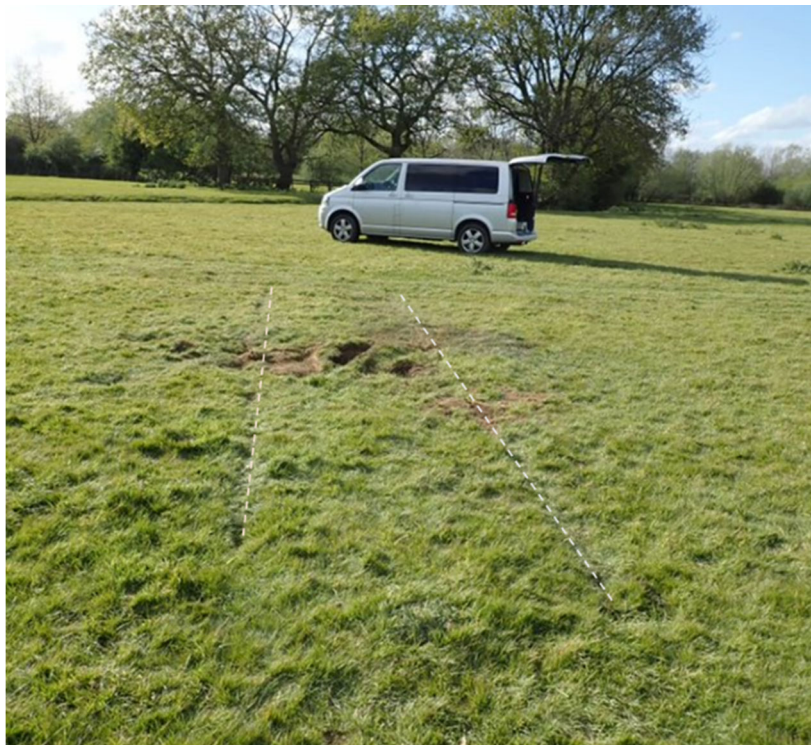
**Figure 6**

Marks left by the mainplane leading edges

The ground marks made by the wings showed that the aircraft hit the ground at 65° to the horizontal. The aircraft was predominantly constructed of lightweight plywood, over a wooden frame with a fabric covering. It therefore offered little inherent crashworthiness. When the aircraft hit the ground at this angle, most of the energy was transferred longitudinally through the airframe. The nature of the materials meant that they splintered and fragmented rather than absorbing energy by attenuation. This left no survivable space, affording no protection to the pilot and, although he was wearing his harness correctly, the seat and emergency lap strap attachment points failed early in the impact sequence. He was then unrestrained.

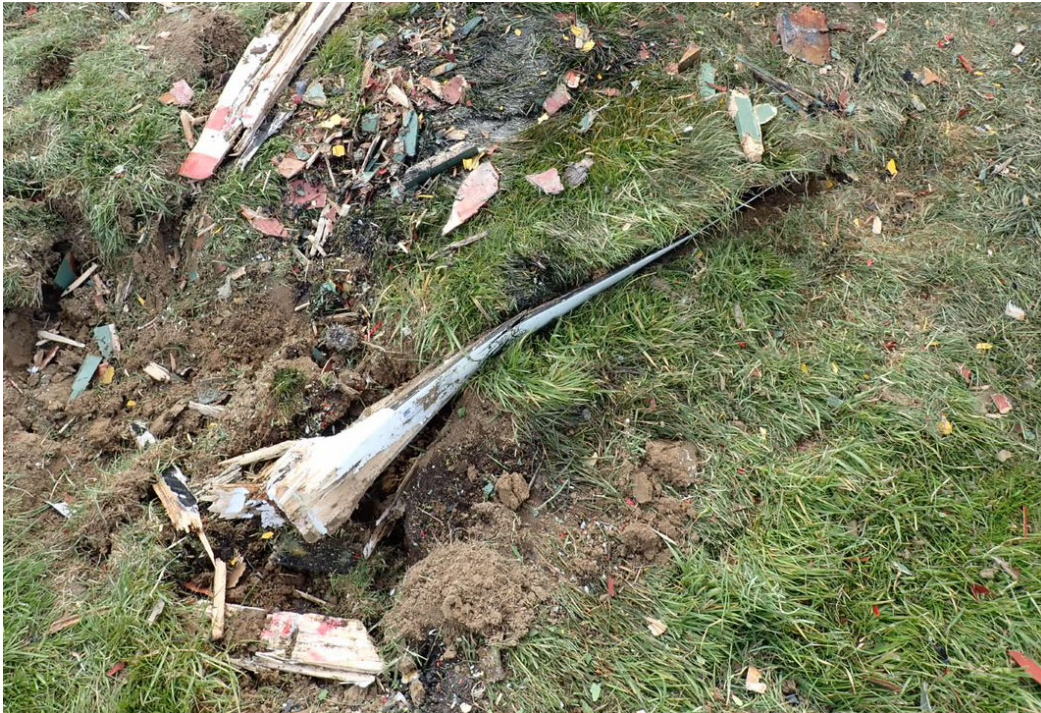
**Figure 7**

Propeller as found in the accident site (engine lifted clear)

One of the propeller blades had detached from its root, had fragmented, and was found lying beneath the aircraft. It was also split along its chord from tip to root on the largest fragment. The other blade was also detached at its root and had made a deep cut into the ground along its length. It had also bent forward and had started to break mid-way along its aerofoil section (Figure 7).

The engine ancillary equipment was severely damaged by the impact, but the block and cylinder heads were intact. However, fragmentation of one of the propeller blades and the forward bend of the other blade, indicated the engine was rotating and producing power when the aircraft hit the ground.

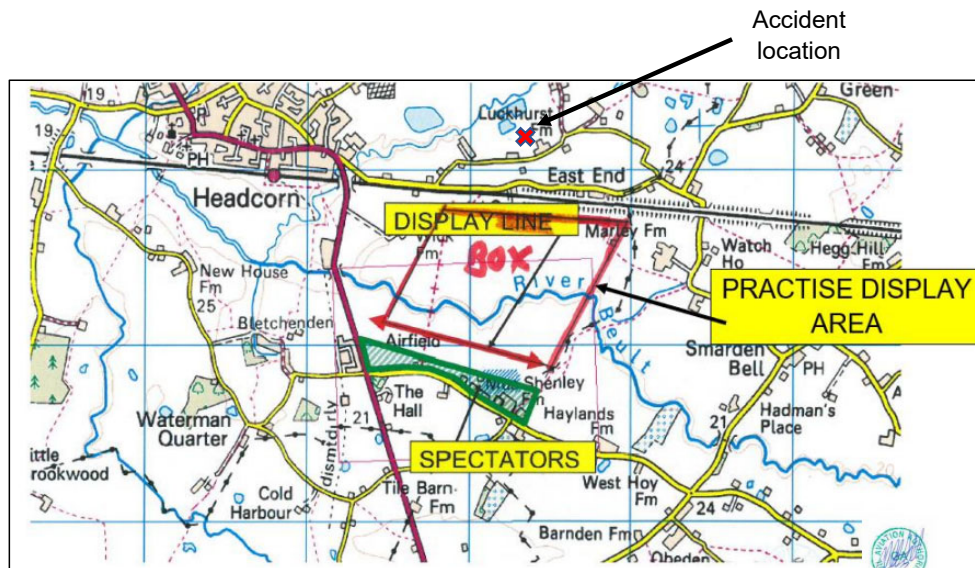
**Figure 9**

Extract from the CAA LTP issued to Headcorn Aerodrome with the accident location added (marked by a red cross)

As shown in Figure 9 the accident location was to the north of the practice display area.

The accident occurred to the north of the practice display area. There is no requirement for the aircraft to remain within the display area throughout the display, but whilst outside the area they must comply with the standard SERA minimum height rules. The formation leader reported that the south-south-westerly wind on the day of the accident caused the aircraft to drift further to the north than intended. Whilst the aircraft were not intending to be below 500 ft and were not over a congested area so were not in breach of the regulations, their location meant that the manoeuvre was being flown close to farmhouses to the north of the airfield. A more detailed briefing with a DAE may have identified this hazard and given the opportunity to modify the display.
