**ACCIDENT**

<b>Aircraft Type and Registration:</b>	Stampe SV4C(G), G-AWEF
<b>No &amp; Type of Engines:</b>	1 De Havilland Gipsy Major 10 Mk.2 piston engine
<b>Year of Manufacture:</b>	1947 (Serial no: 549)
<b>Date &amp; Time (UTC):</b>	9 May 2021 at 1521 hrs
<b>Location:</b>	Near Headcorn Aerodrome, Ashford, Kent
<b>Type of Flight:</b>	Private
<b>Persons on Board:</b>	Crew - 1                      Passengers - None
<b>Injuries:</b>	Crew - 1 (Fatal)           Passengers - N/A
<b>Nature of Damage:</b>	Aircraft destroyed
<b>Commander's Licence:</b>	Private Pilot's Licence
<b>Commander's Age:</b>	57 years
<b>Commander's Flying Experience:</b>	753 hours (of which 517 were on type) Last 90 days - 8 hours Last 28 days - 5 hours
<b>Information Source:</b>	AAIB Field Investigation

**Synopsis**

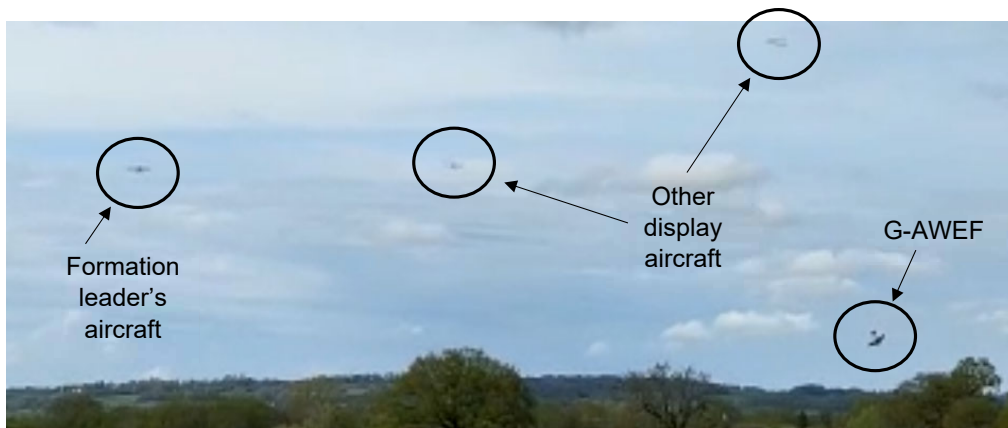
**Figure 2**

Several witnesses were filming and photographing the aircraft during the display practices. However, none of the footage provided to the AAIB captured the stall turn. One witness, who was at the airfield, captured footage of G-AWEF in the spin, a still from which is shown in Figure 2. The aircraft was also captured by a CCTV camera, stills from which are shown in Figure 3.

Mobile phone footage shot by a spectator at the airfield (used with permission)

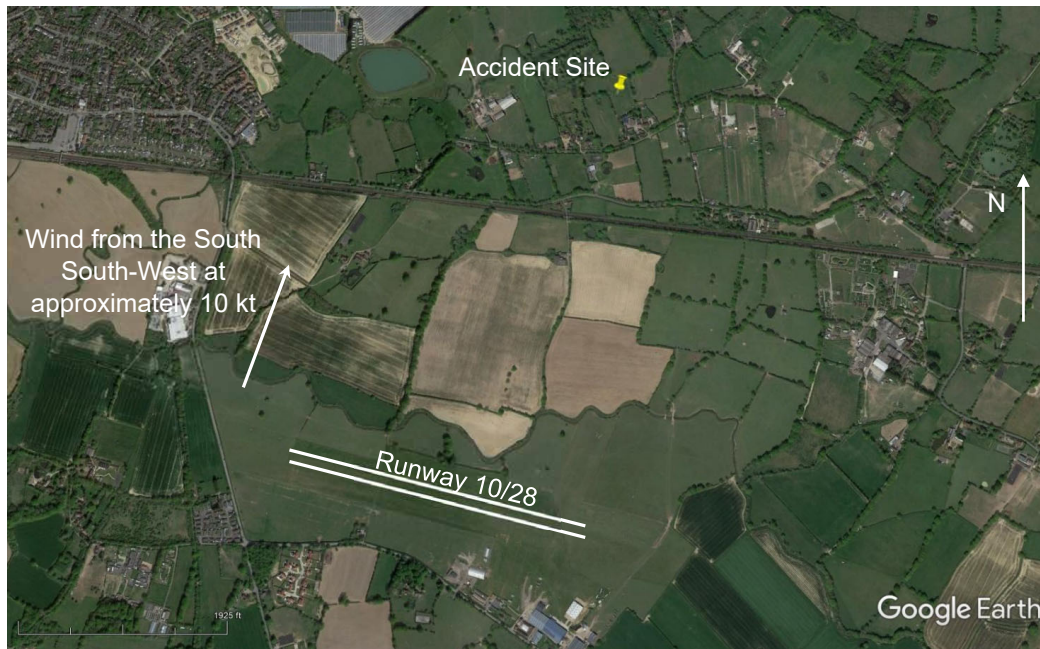
**Figure 4**  
Accident location

The aircraft struck the ground in a field approximately 1 nm north of the aerodrome (Figure 4), there were no signs of fire. An angler who was fishing in a nearby lake ran to the accident site to assist the pilot. He recalled that he arrived within a few seconds of the impact and managed to get to the pilot but there were no signs of life. The other three aircraft circled above the accident site and directed the aerodrome emergency services to the location. Once the emergency services had arrived, the three remaining aircraft returned to the aerodrome and landed normally. An air ambulance also attended the scene. However, the pilot could not be revived.

The aircraft hit the ground in a large open agricultural field and came to rest upright on a north-easterly heading. Initial examination of the wreckage indicated the aircraft was complete with no vital parts or control surfaces missing. The tail section, from the rear cockpit seat frame aft, was undamaged other than some distortion and splitting of the left tailplane tip structure. Both cockpit areas and the engine bay were extensively fragmented (Figure 5). The upper and lower wing leading edges had been compressed and distorted along the full length of both wings. The upper wing bracing struts and rods had been cut by the first responders and the wing had been moved forward to gain access to the pilot. After the aircraft was removed from the accident site, two distinct parallel marks had been left on the ground by the mainplane leading edges (Figure 6). Comparison of these ground marks with the aircraft's original structural dimensions suggest that the aircraft hit the ground with a 65° nose-down attitude.

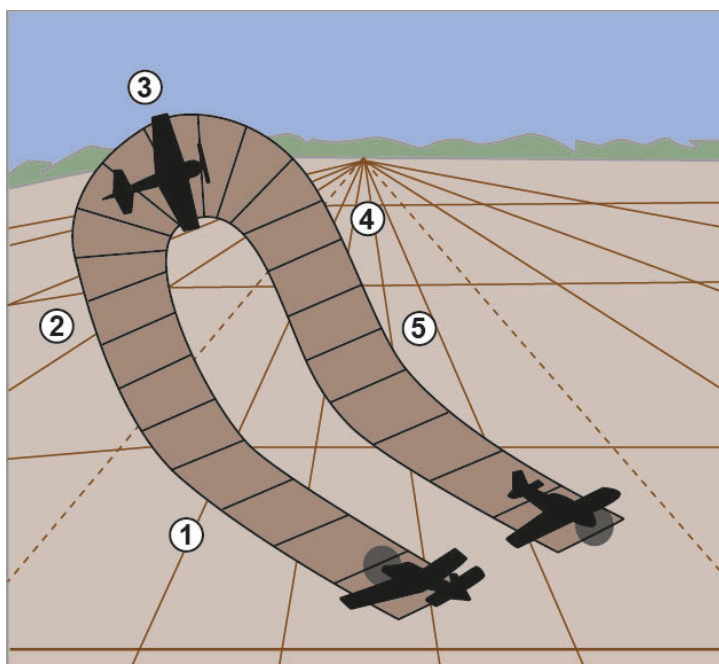
**Figure 10**

Flight tests conducted during the investigation showed that the most likely reason the aircraft entered a spin was that either too much aft stick was applied before the yawing turn was complete or that the rudder was not centralised when the pull-out was commenced. The investigation identified several reasons why this may have occurred.

A diagrammatic representation of the stall turn is shown in Figure 10. The team reported that the whole manoeuvre was normally flown with full power applied. In Figure 10, depicting the intended manoeuvre:

- When in position 1, on the display leader's command, initiate the climb with an aft stick input and left rudder to keep the aircraft in balance.
- At position 2, on the display leader's command, apply full right rudder to rotate the aircraft through 180°. As the aircraft rotates around the lower wing, left aileron might be required to stop the aircraft rolling right due to the secondary effects of the rudder input.
- When the aircraft approaches position 4 and is pointing straight down, centralise the rudder to stop the yaw and allow the aircraft to accelerate in the dive. Once airspeed has built-up sufficiently, apply aft stick to recover to level flight.

Diagram of a stall turn
